# In Search of Horta: On-Site Examinations and Results

Wivine Wailliez

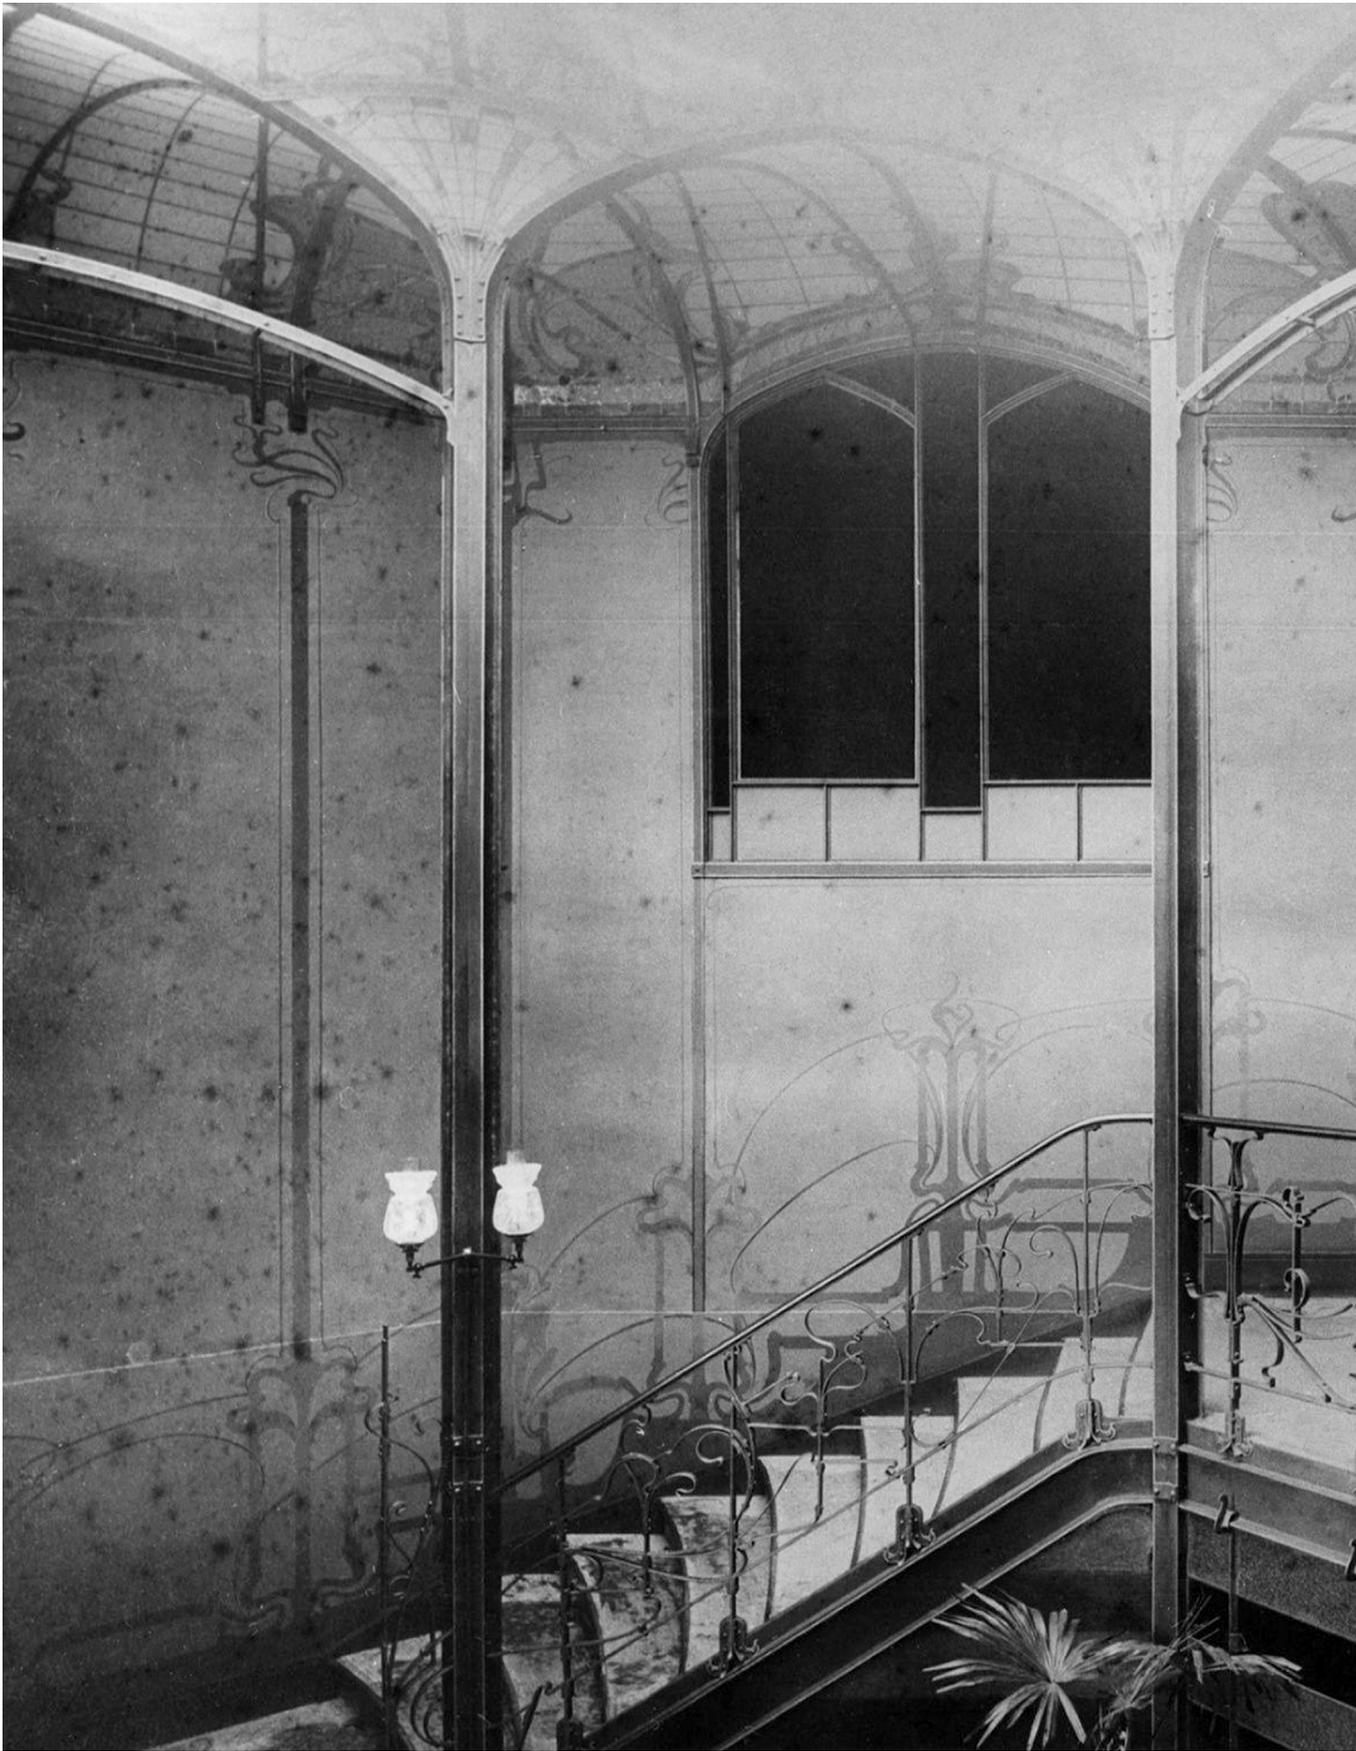
**FIG. 1** Hôtel van Eetvelde, winter garden, western wall, ca. 1897–98 © IRPA-KIK.

In 1897 there was still no opening in the western wall [FIG. 1](#); the paintwork shows elegant pilasters and capitals and low contrasted borders. At the time of the second construction phase, the new west wing was connected to the main building via a large arch in the winter garden, walled up after Mrs van Eetvelde's death and the sale of both the west wing and the residential rental property in 1919. Just after the wing construction, electric fittings replaced gas lighting and the original glass plates in the octagon gave way to green marble plates, but the paintwork still remained the same at that time. Shortly after (c.1900) [FIG. 2](#), but still before the opening of the east wing, the mural decoration was overpainted with the second decorative scheme, displaying a higher contrasted border. After the building of the new wing (after 1901) [FIG. 3](#), the decoration changed again, and the third decorative scheme returned to lower contrasted borders. The early motifs and palette followed by the second and third ones constitute successive "original" schemes, responding to the extensions of the building by Horta himself.

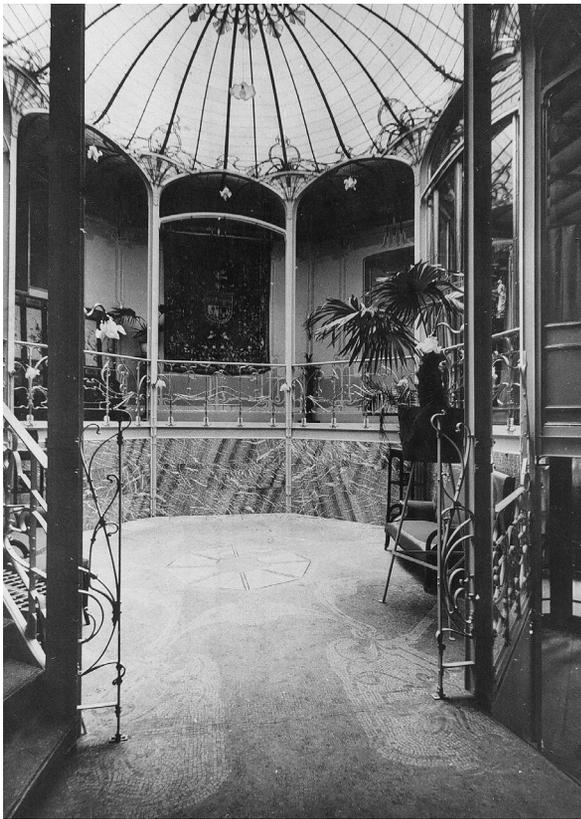
FIG. 2 Hôtel van Eetvelde, winter garden, eastern wall, ca. 1900 © IRPA-KIK.

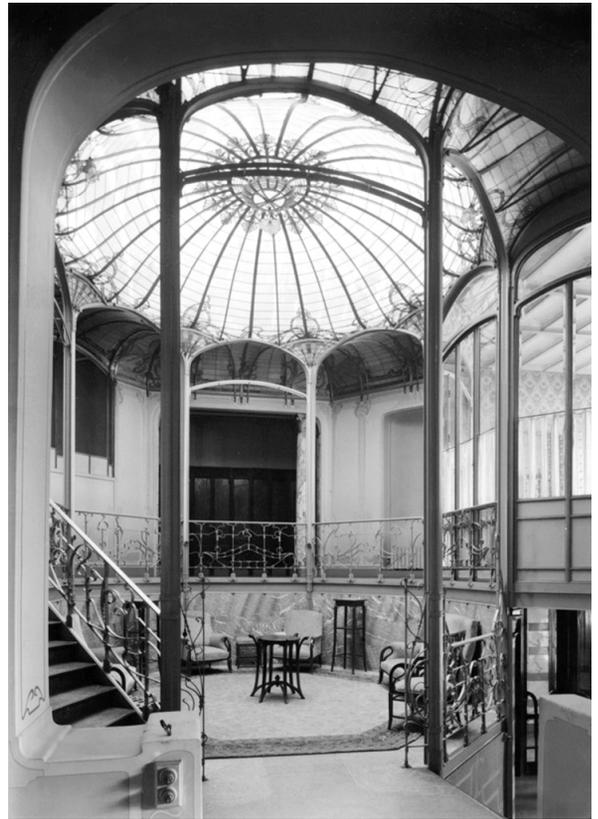
FIG. 3 Hôtel van Eetvelde, winter garden taken from the western wing, ca. 1917–18, Paula Deetjen © Bildarchiv Foto Marburg.

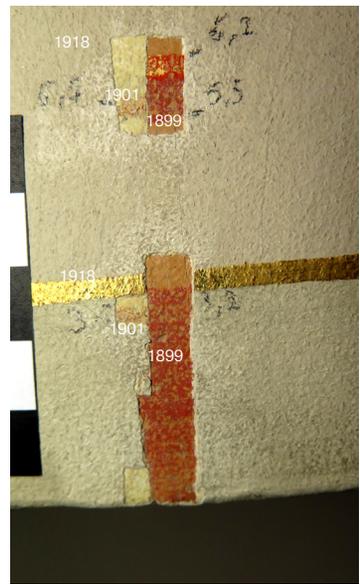
FIG. 4 Hôtel van Eetvelde, winter garden, western wall, stratigraphic exposure, 2017 © Cellule Décors de Monuments — IRPA.

The on-site examinations aimed to identify the different paintworks and to characterize their palette. The east wing has received two coats of paint, the original one from 1901 and a faithful overpainting from c.1918, the currently visible paintwork. On the western wall the area directly over the arch has been examined. However, instead of uncovering three historical paint jobs under the 1918 overpainting, stratigraphic exposures have only revealed two; moreover, the

first paintwork at that place was applied as part of the second decorative scheme, as evidenced by the fact that it is underlining the arch [FIG. 4](#). On the eastern winter garden wall, in oblique light we can make out a slightly shifted underlying decoration. On that spot, there are four paint systems on top of each other: colour-wise, the first one matches the second decorative scheme, just like on the opposite wall; the next two belong to the scheme of 1901 and a local undated overpainting (a repair); and the current visible layer from 1918. It means that there too the original scheme has vanished. Horta's very first scheme for the winter garden may well not have been uncovered/recovered so far: it may lie under the canvas glued to the wall. Nevertheless, the discovery, albeit partial, of the 1899 and 1901 palettes is a very valuable contribution to the history of Art Nouveau.

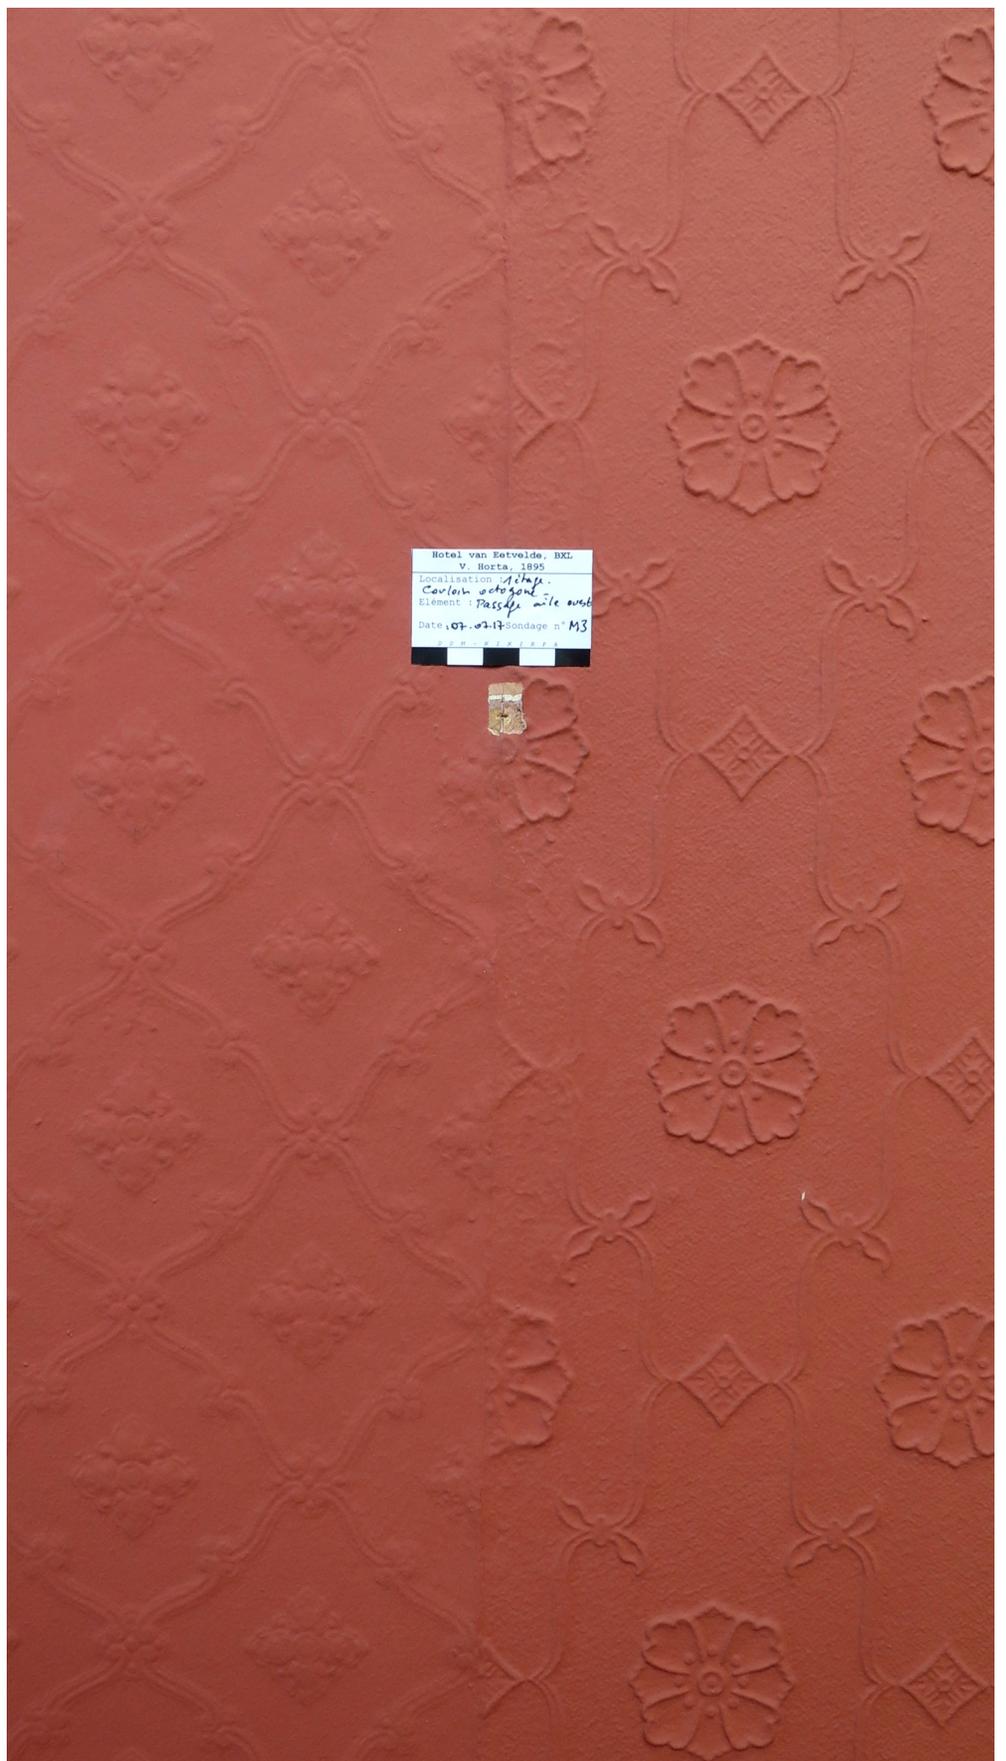
Hotel van Eetvelde, BXL.  
V. Horta, 1895  
Localisation: *Stijl*  
Context: *architect*  
Element: *Passage - site ouest*  
Date: *07-07-17* sondage n° *M3*

FIG. 5 Hôtel van Eetvelde, first floor, western side, 2017 © Cellule Décors de Monuments — IRPA.

Back to Horta's Hôtel van Eetvelde, in the first-floor gallery around the winter garden's light shaft, where our investigation had revealed an unknown, walled-up bay on the western side. All the staircase and first-floor corridors are hung with a floral Lincrusta wallcovering,<sup>9</sup> except for a single *patch* of another pattern, at first sight a repair, on the western wall [FIG. 5]. Stratigraphic exposures of the paint layers on both Lincrustas at their boundary show clearly that the repairing patch is already old. Trying to understand, we put forward the hypothesis of a passageway leading to the left wing on the first floor, that had to be bricked up in 1919, just like the arch in the winter garden. Horta specialists had no inkling of this passageway, and the archives and plans did not give any clue on this subject. Of course, deeper examination — up to the plaster and the masonry — should allow us to verify our hypothesis, but the conservation of ancient elements prevented further examination.
