Cristina Oliveira¹, Humberto Varum², Aníbal Costa³

ADOBE IN ART-NOUVEAU CONSTRUCTIONS IN AVEIRO

Abstract

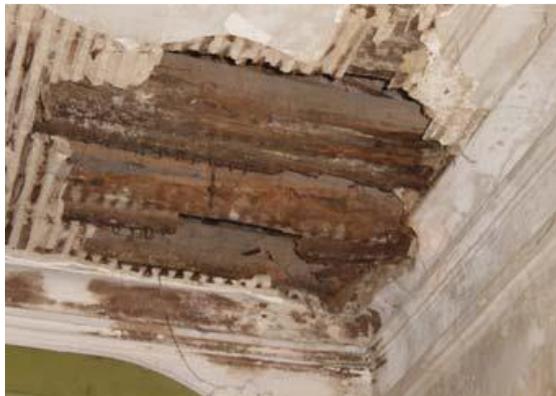
Figure 2 – Deteriorating wooden beams floor ([Varum, H. et al (2005b)])

Due to moisture and infiltration, it is usual to find a strong degradation in wood elements, common in floors and roofs beams of these structures (Figure 2). The presence of water causes the swelling of the wood elements by installing a tension state giving rise to bending, distortion and cracking [Arriaga, F. et al (2002)]. In addition, the water makes the environment favourable to the development of biological agents whose action causes the degradation of wood. High degrees of degradation may also affect the binding of the floor and roof joists to the walls structures, placing at risk building safety.

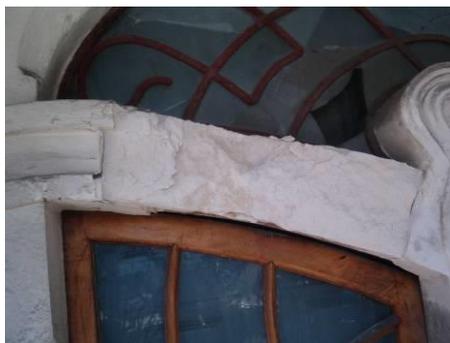
Figure 3 – Advanced state of degradation of a limestone façade ([Varum, H. et al (2008a)])

The facades of some of these constructions used stone, which may bring specific pathologies. Depending on the type of stone used, it may present different levels of degradation (Figure 3). Porous and permeable rock such as limestone, to provide circulation of water therein, is functioning as transport vehicle for damaging chemical agents for stone itself and to other construction elements.

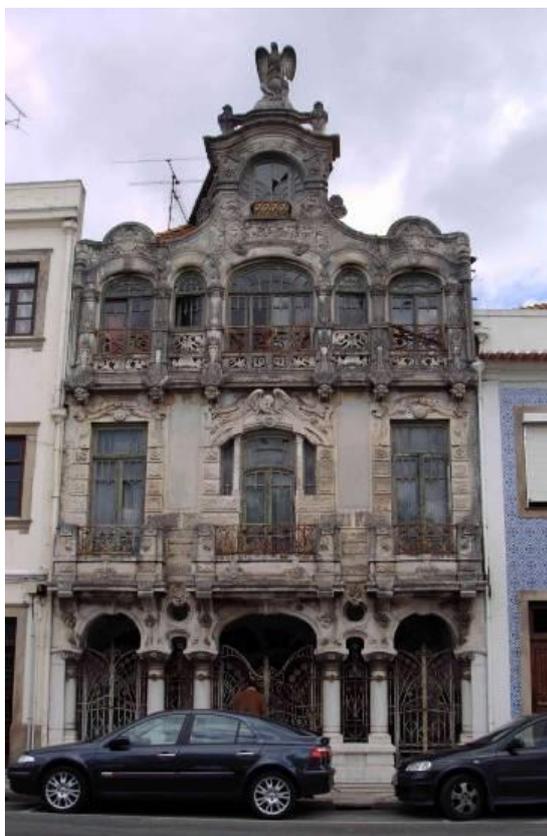
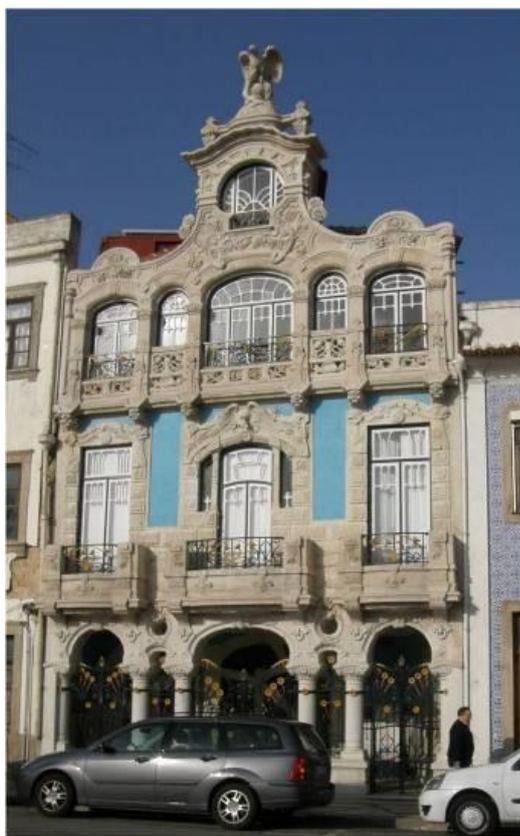
Figure 5 – Major Pessoa House: a) before the intervention [Varum, H. et al (2008b)], b) after the intervention (photo: C. Oliveira)

At the time, the numerous pathologies present were due mainly to lack of maintenance. Infiltration, deterioration of the wooden structure, local crushing on the resistant walls, deformations of the façades, were, among others, some of the problems observed, which were questioning the durability of the building and even its overall stability (Figure 5).
